**ENVIRONMENTAL PROTECTION AGENCY
TECHNICAL ENFORCEMENT SUPPORT
AT
HAZARDOUS WASTE SITES**

**FINAL
RCRA FACILITY ASSESSMENT REPORT
FOR
ARMCO, INC.
KANSAS CITY, MISSOURI
U.S.EPA SS/ID NO. MOD007118029
U.S. EPA REGION VII**

**WORK PERFORMED BY:
TETRA TECH, INC.
10 CAMBRIDGE CIRCLE DRIVE
SUITE 130
KANSAS CITY, KANSAS 66103
(913) 621-6041**

January 14, 1992

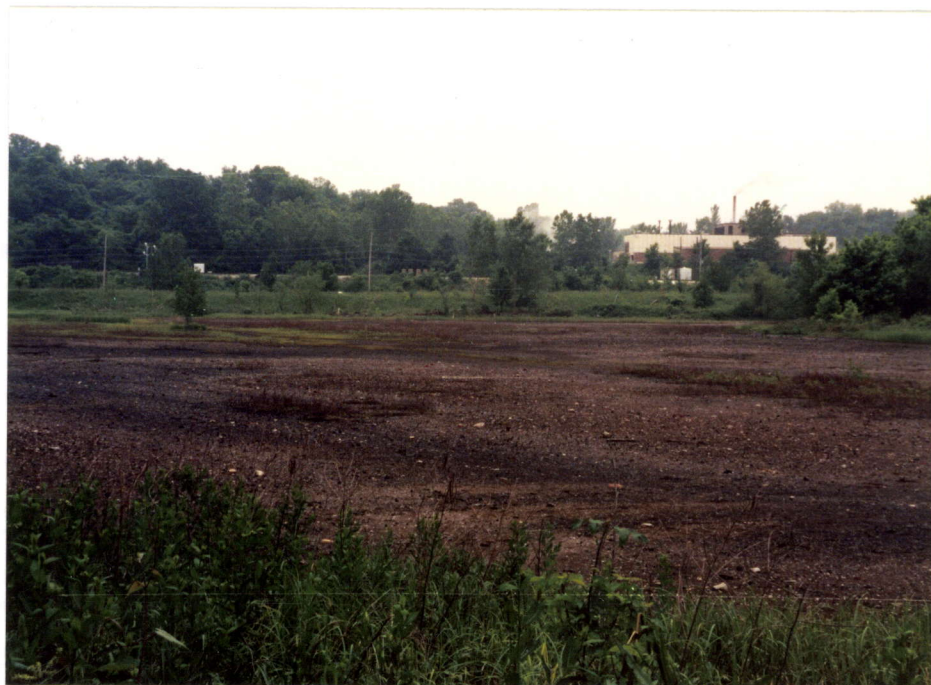
Photograph Number : 1

The petroleum waste on this site is now considered hazardous waste, though it was not classified as such at the time the landfarm (Photos No. 1 and 2) was in use. Mr. Alan Hancock of the U.S. EPA RCRA Enforcement Group, who is working on the AMOCO Sugar Creek Site, states that this site is not covered by the Enforcement Action against AMOCO. He was unaware that this site existed, and stated that as far as he knows no work is being done by the Enforcement Group to ensure cleanup of this site (Ref. No. 79). Mr. Lewis Sutton of AMOCO, is attempting to locate information on these wells

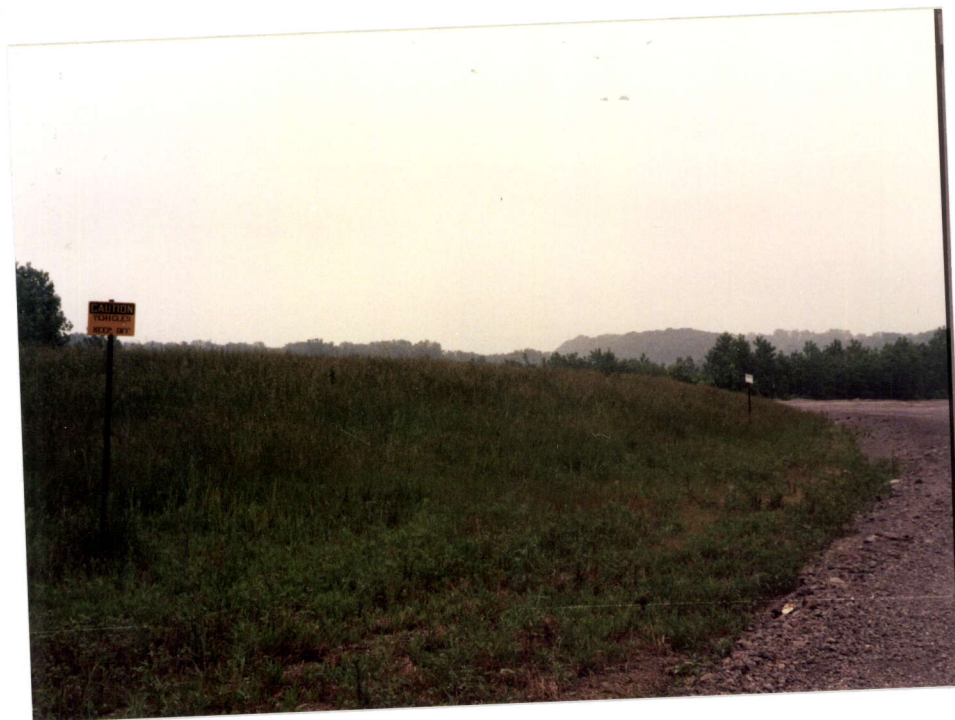
Photograph Number : 3

According to the PCPA, this landfill was in use from 1965 to 1980, and covers approximately 15 acres. The landfill is an old channel of the Blue River, and contains approximately 185,000 yd³ of baghouse dust mixed with "general plant and office trash". The landfill was capped and seeded in 1980. The cap appeared to be in good condition at the time of the VSI. Presumably, the non-baghouse waste is non-hazardous. ARMC0 reported this landfill to the U.S. EPA in 1980. In 1984, it was placed on the Missouri Department of Natural Resource (MDNR) list of Confirmed Abandoned or Uncontrolled Hazardous Waste Disposal Sites in Missouri. No Superfund clean up has been initiated, or planned, for this site. This landfill is covered with grass and appeared to be in good condition at the time of the VSI (Photo No. 3).

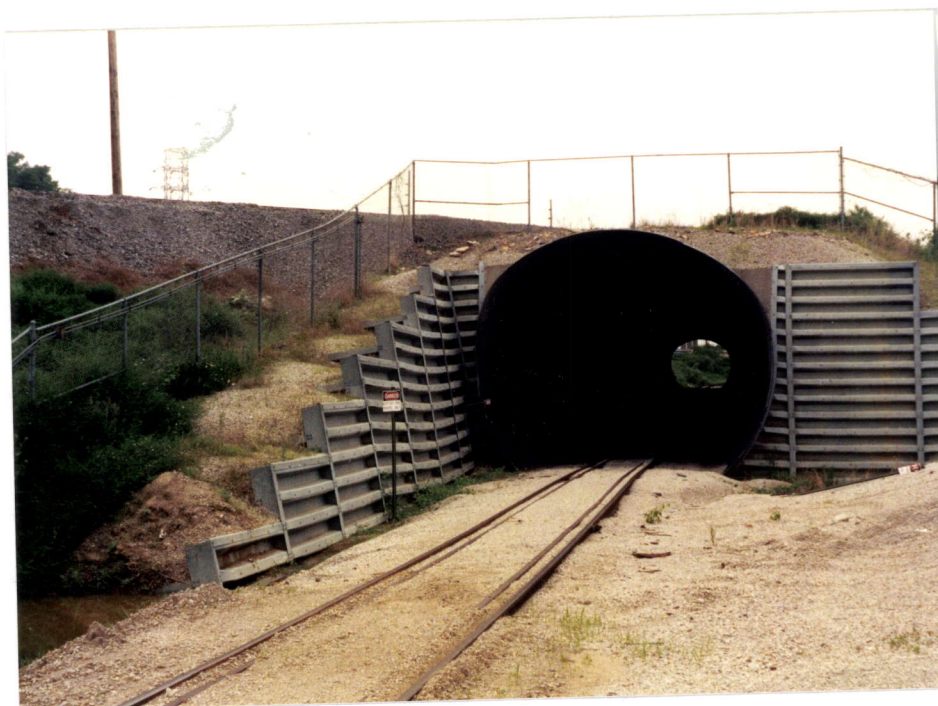
Photograph Number : 7
Photograph Date: 5/20/91
35mm; 400 ASA; Speed: Automatic
Photograph Subject: Rock Creek Railroad Tunnel.
